FACILITY CONDITION ASSESSMENT

Police Department

20 Police Plaza, Geneva IL

DATE: 10/18/2021

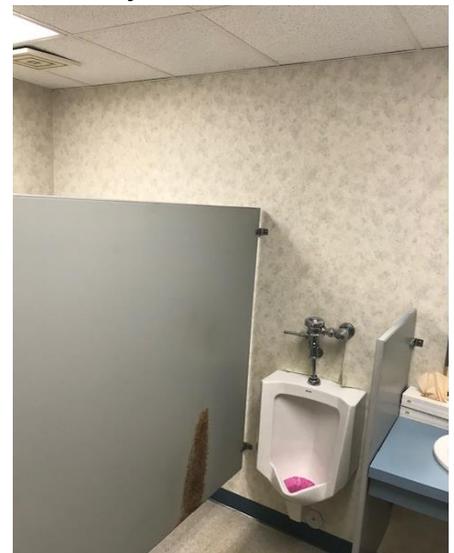
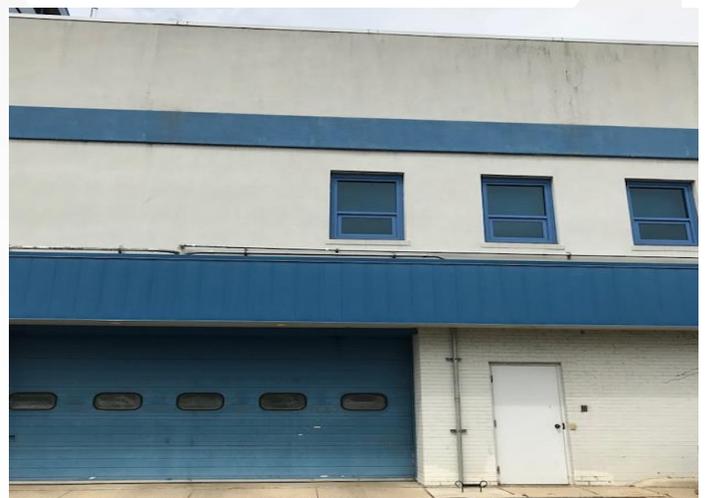
- **Windows and Doors:** *The doors and windows are predominately aluminum frame systems. They are in fair condition as is to be expected for the age. They need replacement. There are some windows that*

are glass block and have outlived their useful life. One section has recently failed and had to be replaced due to its poor condition. Remaining sections should also be remedied as soon as possible.

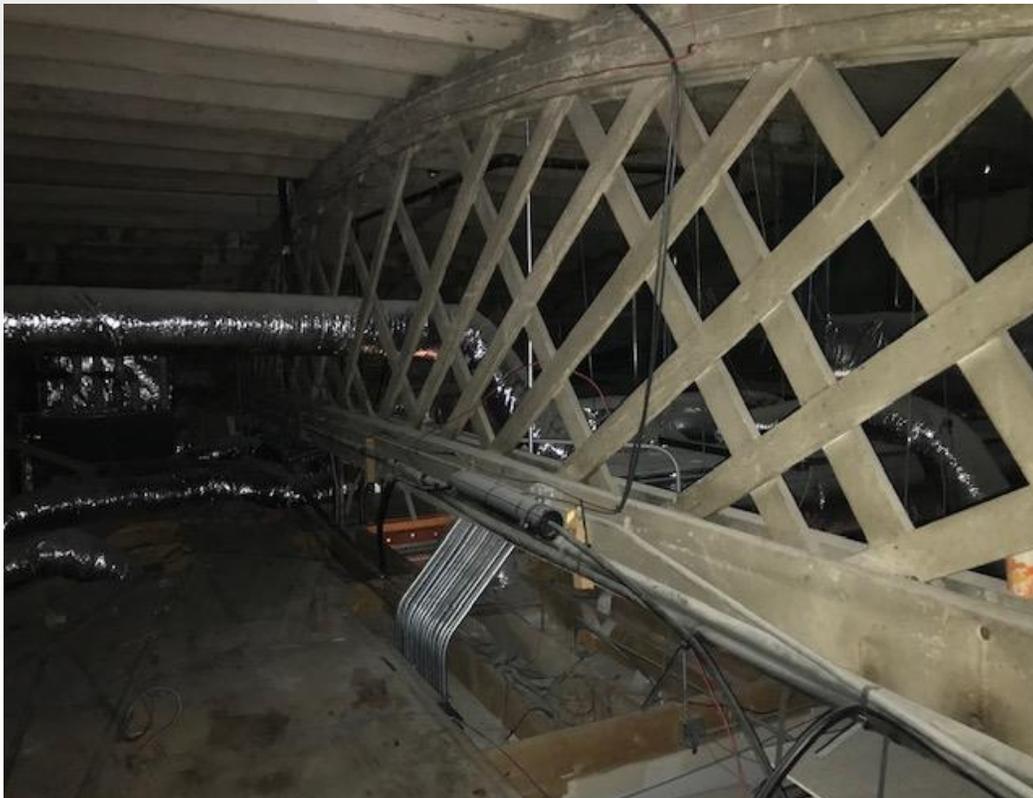
- **Roof:** Across the three buildings there are two different roof systems. The two southern buildings have a true low slope flat roof with modified bitumen or built-up roof. These roofs are past their useful age. It is likely the insulation is significantly deteriorated and will need to be replaced. This will require bringing the entire roof system into energy code compliance. This usually means lifting all the mechanical units to meet manufacturer spacing requirements. The northern building is a modified/built-up roof over wood bowstring trusses. The roof structure is in poor condition and should be structurally evaluated and a program put in place to repair or replace deteriorated members. It is likely this roof will need a full replacement in the coming years. One portion of the roof membrane has been replaced but did not resolve the underlying structural concerns due to age.

- *More conference rooms and larger staff areas.*
- *Obtain a roof maintenance contract for regular documented assessment and repairs.*
- *Building addition(s) to allow for department reconfiguration to gain operational efficiencies and to meet the growing expectations of a modern police department.*

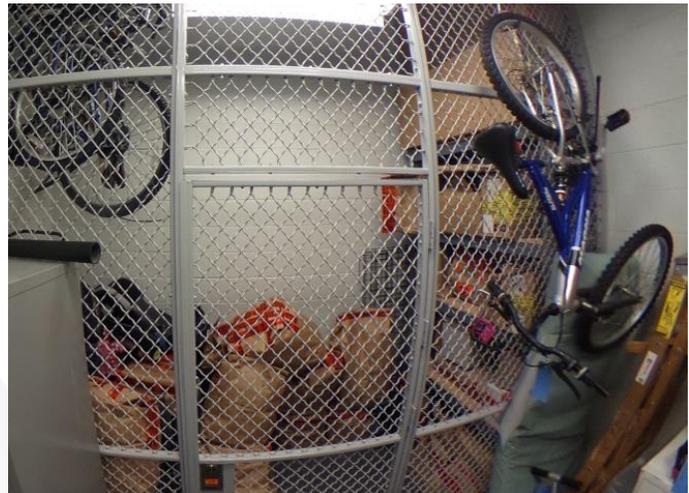
- **Storage Space:** *Storage is a standard concern in all police stations. Due to the evolution of legal requirements to store evidence, there is not enough storage. Large evidence storage is being housed over at public works in portable containers, the long-term storage has become temporary bike storage, and all the traffic control systems are stored in*

the vehicle garage that doubles as an animal control area. This area also does not contain sufficient room to store the anticipated expansion of the equipment and specialized vehicle needs for an urban force with a significant amount of bike and foot paths. The lack of adequate storage is contrary to best police practices and creates challenges for maintaining adequate chain of custody. Additionally, there is growing need for storage of specialized vehicles including all-terrain vehicles.

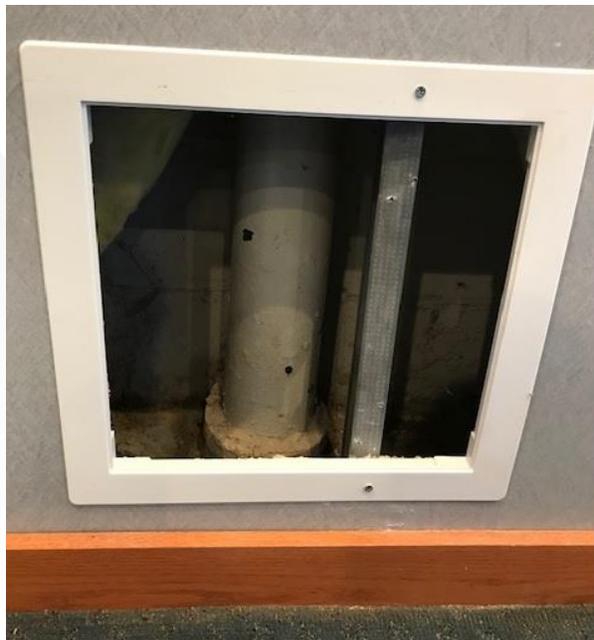
Existing cast iron storm piping at roof drains is deteriorating at leaded joints causing numerous leaks and catastrophic flooding. Failure of these pipes often occur during heavy rains that result in significant flooding issue.

- *An RPZ backflow preventer should be installed on the potable domestic water pipe serving the building to protect the city water supply from the building potable water service. A floor drain should be added near the water service to serve the RPZ backflow preventer.*
- *Add thermostatic mixing valves to all public lavatories.*
- *Provide a backflow preventer on sprinkler head and limit dead-end piping.*
- *Replace area drain with a larger drain at Bond exterior door to prevent flooding.*
- *Replace existing sections of sanitary sewer in poor condition from building to street sewer.*
- *Replace and reroute sections of existing sanitary piping in poor condition serving kitchen sink.*
- *Replace sections of existing suspended storm piping serving roof drains where cast iron leaded joints are failing.*

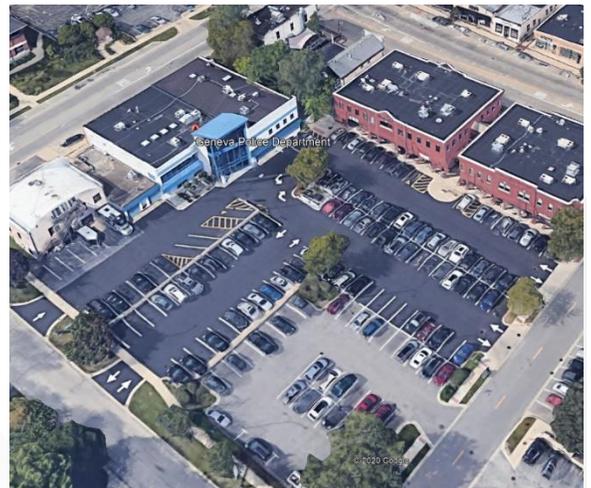
- *Site security is critical to the safe operations of the staff and the public. The lack of a secure environment for staff and the safe transfer of prisoners in and out of the facility is a significant concern.*
- *A security perimeter should be constructed to allow for an access-controlled entry into the staff parking, patrol car parking, sallyport, and a dedicated staff entrance.*
- *There are no barriers to prevent a vehicular attack on the entry of the building.*

- *Site: Replace all cameras.*
- *Site: It is recommended that access control parking be provided for staff with a controlled access route to the building. This can be provided in many other ways than fencing, robust landscaping or ornamental fencing will provide enough awareness to the separation of staff and public spaces.*

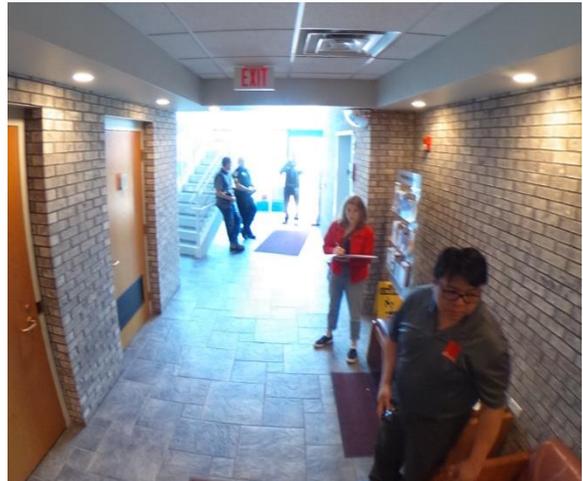
- *The facility has an access control system that records identification and logs access. The use of the system should be more robust to include more areas of the building. This is a critical requirement for a police station.*
- *The main entry is co-utilized by staff and the public. These functions need to be separate to provide the proper level of monitoring and access control. This is also an important component of employee safety where those reporting for work walk into a situation in the main entrance.*
- *The entry to the building is not visible from the reception/records staff. This is a significant safety concern.*
- *There are hidden areas in the lobby area that are not monitored or visible from staff locations. A ill-intended person can get into the buidling and up to the admin floor*

without being seen. This is a safety concern to all of the administrative staff.
