# Sanitary Sewer Evaluation: Geneva East Basin

City of Geneva

Prepared For  
The City of Geneva

Prepared By  
Deuchler Engineering Corp.  
230 Woodlawn Avenue  
Aurora, IL 60506  
[www.deuchler.com](http://www.deuchler.com)

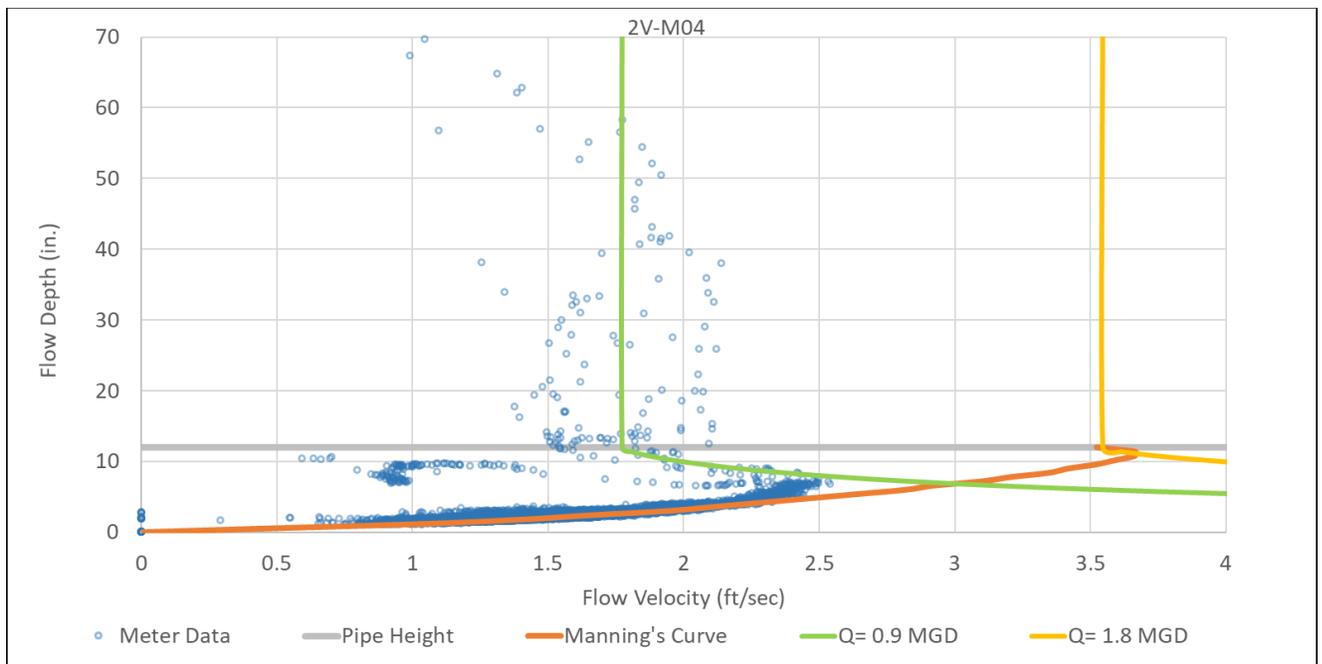
“Downstream Control” is a term commonly used in flow monitoring. This term refers to a restriction of flow shown at a flow monitoring site. Figure 3-1 shows the downstream control seen at 2V-M04 (877 Manchester). Downstream control limits the flow capacity of the pipe and backs up the sewers upstream of it. In this case, the pipe has a theoretical full-pipe capacity of approximately 1.8 MGD, but is only able to pass 0.9 MGD. Once the flow reaches 0.9 MGD, a restriction downstream does not allow any more flow to pass through. When more than 0.9 MGD of flow enters from the upstream sections, the water elevation rises and the flow begins to back up. This is seen in the chart as well, with elevations reaching nearly 70 inches above the invert (bottom) of the pipe.

With the downstream control seen at 2V-M04, the need to add flow meters further downstream became apparent. A meter was installed at 3W-M24 (behind 27 Ridge Ln) on May 15<sup>th</sup> just in time to record the flows for the remainder of the wet weather event. This data still showed downstream control, which led to the installation of 4V-M24. The analysis at 4V-M24 is ongoing due to the lack of rain since the meter was installed.

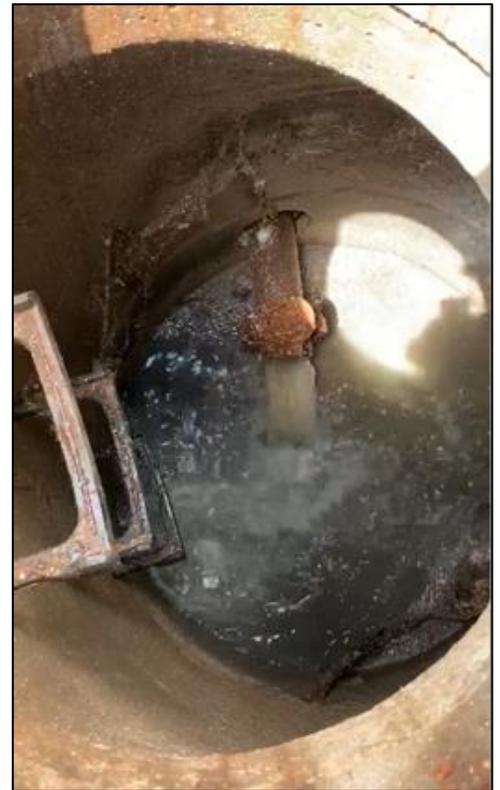
A manhole inspection of 1V-M24 (634 Westfield) revealed that the force main from the lift station at the south end of Parker Ct discharges directly onto the flow path. This flow discharge creates a hydraulic disturbance and creates “downstream control” in the sewers upstream of it. When the level upstream in the wet well of the pump station reaches a certain level, the station will turn “on” and pump 165 gallons per minute. When the level has subsided to a predetermined design point, the pumps will shut “off”. This flow converted to Million Gallons per Day is equal to 0.24 MGD. The dry weather flows recorded to date for 1W-M15 show a daily peak of 0.04 MGD flowing through this manhole. This discharge, six times larger than the established flow, crashing down at a high velocity contributes to a reduced capacity in upstream sewers for the duration of pumping.

Figure 3-2 shows the discharge creating surcharge and turbulence in 1V-M24.

The need to reroute the force main will be contingent upon the wet weather flow data for the upstream meter located at 1W-M15. During dry weather, the surcharging appears to be localized at the force main discharge point and does not appear on the upstream flow data. Additionally, with low run times and only serving 35 homes, downsizing the pump capacity at the lift station would help limit the hydraulic disturbance in 1V-M24.

The force main discharge into 1V-M24 creates a hydraulic disturbance that temporarily holds the upstream flow back. Recommendations for this location, such as pump downsizing and/or force main realignment will depend upon the results of the complete flow study currently underway. If no downsizing and/or force main realignment takes place, it is recommended to re-design the entry path of the force main discharge into 1V-M24. This will reduce the hydraulic impact of the flow entering from the force main.

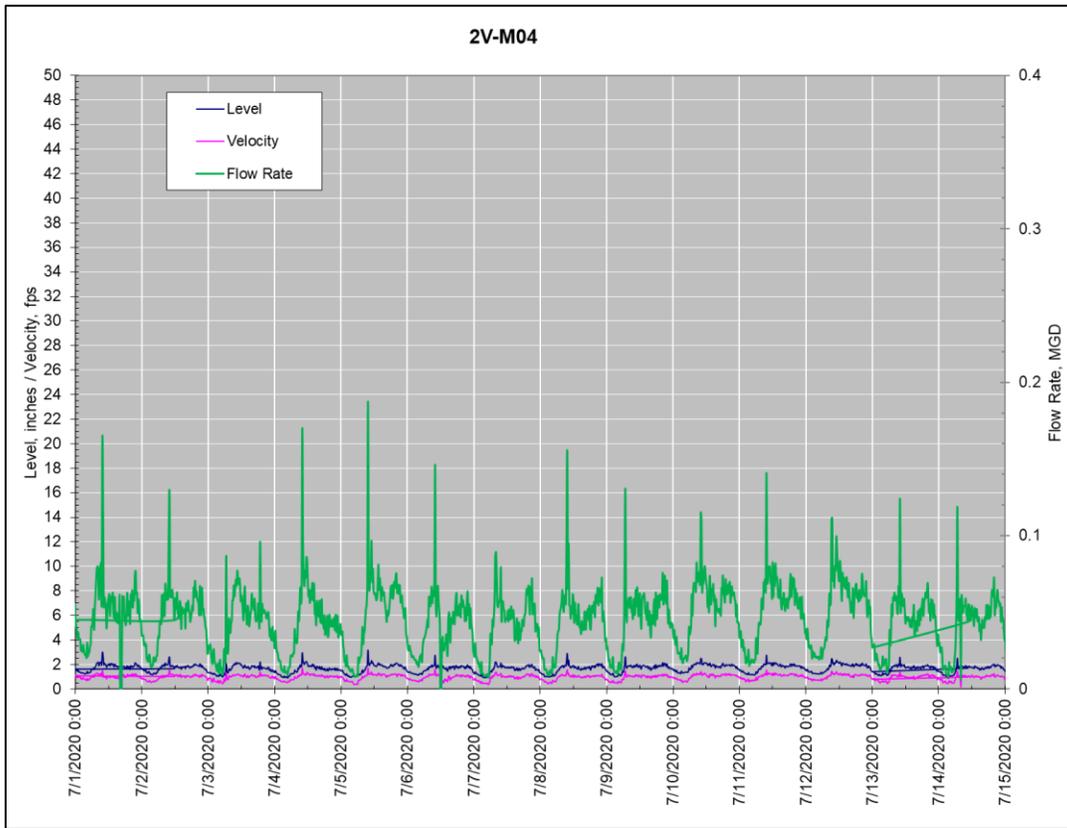
The downstream meter at 2V-M04 shows flow spikes once a day during the first half of July. These flow spikes can reach up to 0.15 MGD over the previous data points, nearly the flow of the pump station with one pump running. Figure 3-3 shows the data from July 1<sup>st</sup>, 2020 through July 15<sup>th</sup>, 2020.

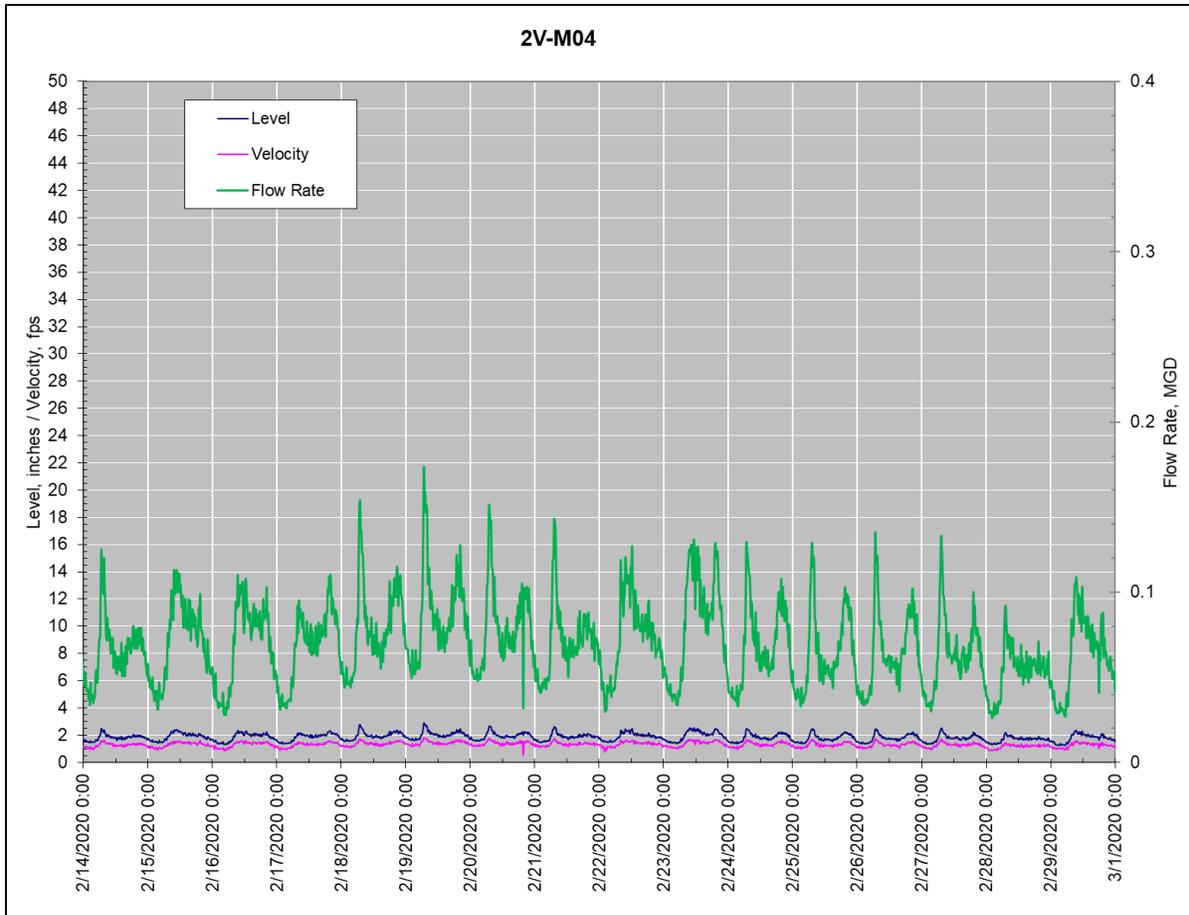
With higher dry weather flows in the late winter / early spring, the peaks are not as pronounced. Figure 3-4 shows the flow from February 15<sup>th</sup>, 2020 through March 1<sup>st</sup>, 2020. With larger dry flows established from upstream of 1V-M24, the force main discharge does not show up as clearly. The extent of surcharge in 1V-M24 will be greater with these higher dry weather flows, however, and will need to be analyzed in the next wet season and major storm event.

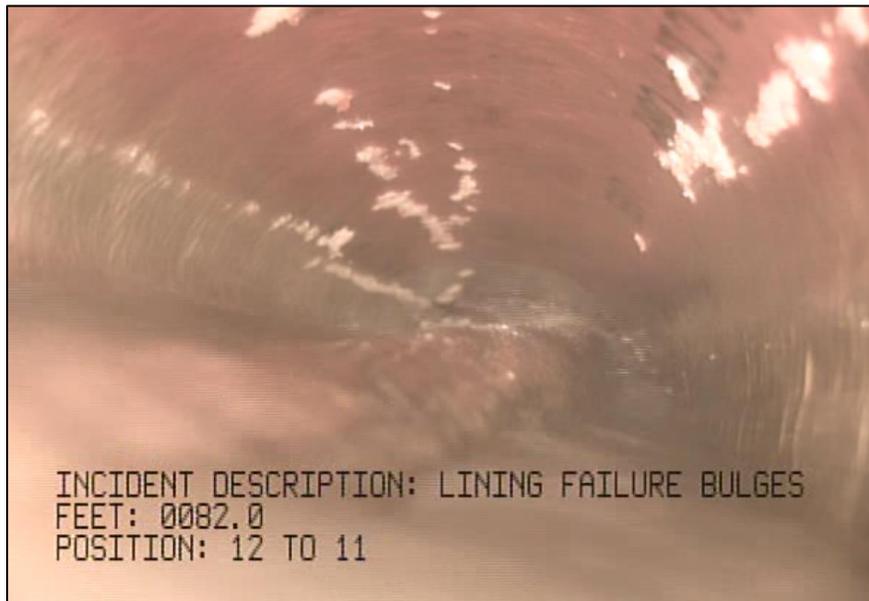
One recommended dig repair was identified during the TV review. The repair is located on 1X-M20 to 1W-M36. A large bulge in the liner is obstructing flow. If not removed, the bulge can potentially lead to backups upstream. Figure 4-1 shows the bulge in this section. Exhibit 4 shows the overall location of the bulge. This repair was made the week of August 24, 2020.

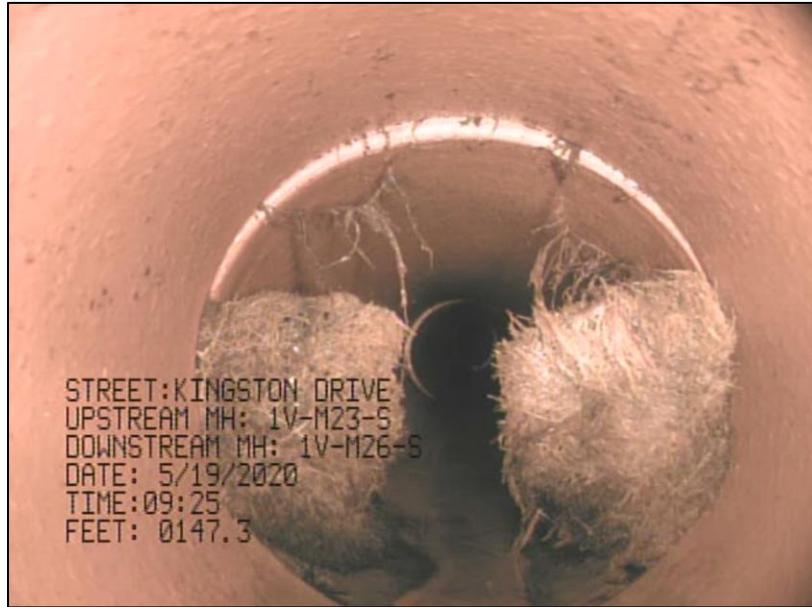
Roots will often enter pipelines at the joints. Roots seek the moisture and nutrients present in sanitary sewers. When roots are found in sewers, they will often continue to grow and become a large obstruction restricting flow. Additionally, the space in the joints that allows roots to penetrate is also a source of I/I. Segments with a significant amount of roots are recommended to be lined with CIPP. Figure 4-2 shows root intrusion at a VCP joint.

The segments with root intrusion are recommended to be lined. Over time, the roots can grow back and penetrate chemical grout. A CIPP liner will ensure that roots are kept out of the main line.

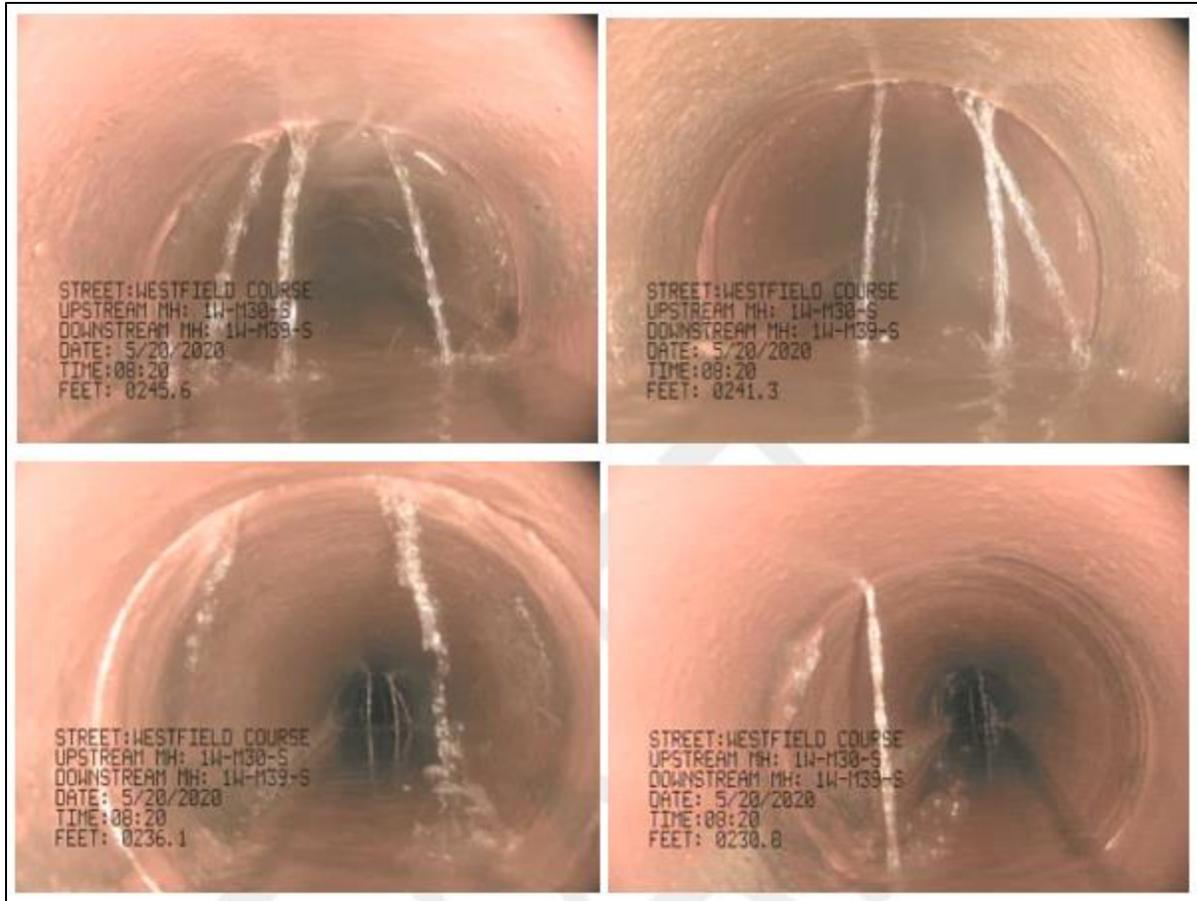
Many pipes are in good structural condition, but show active infiltration or signs of past infiltration. Segment 1W-M30 to 1W-M39 was televised on 5-20-2020, a few days after the heavy rains. This segment showed active I/I at nearly every joint. Figure 4-3 shows a few of the leaking joints.

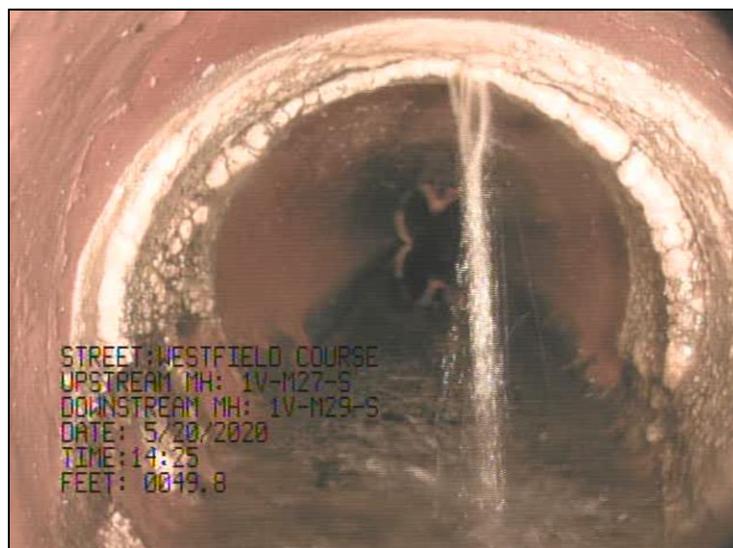
Figure 4-4 shows a strong stream of infiltration into 1V-M27 to 1V-M29.

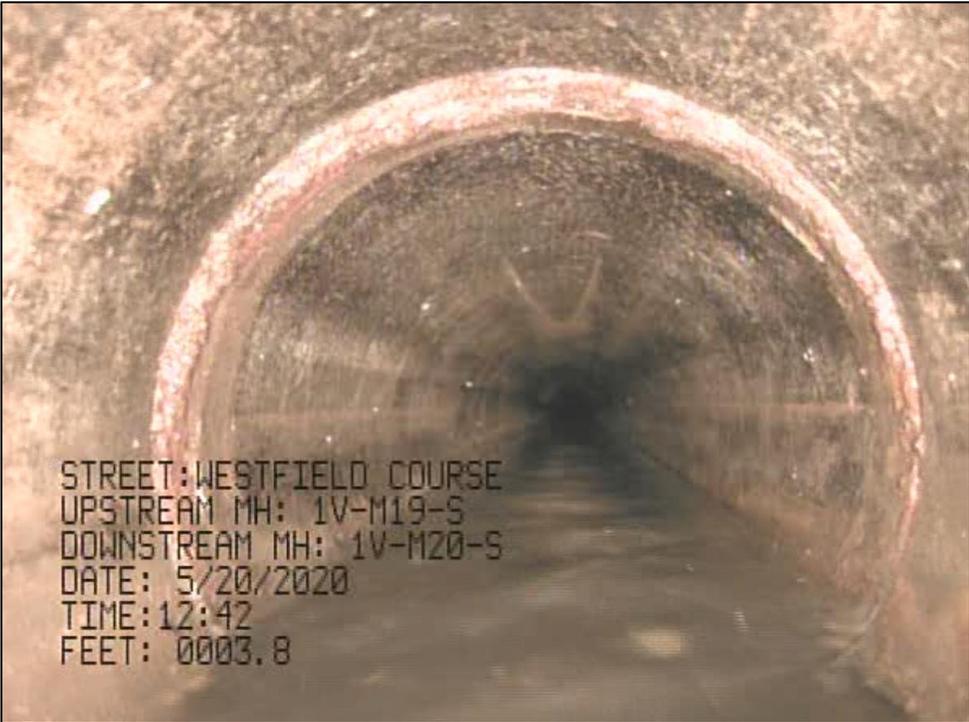
Mineral deposits will often form where a pipe has previously leaked. Deposits were not common in the VCP sewers in the area, they were more prevalent in the Ductile Iron segments. Figure 4-5 shows some light deposits forming at a main line joint.

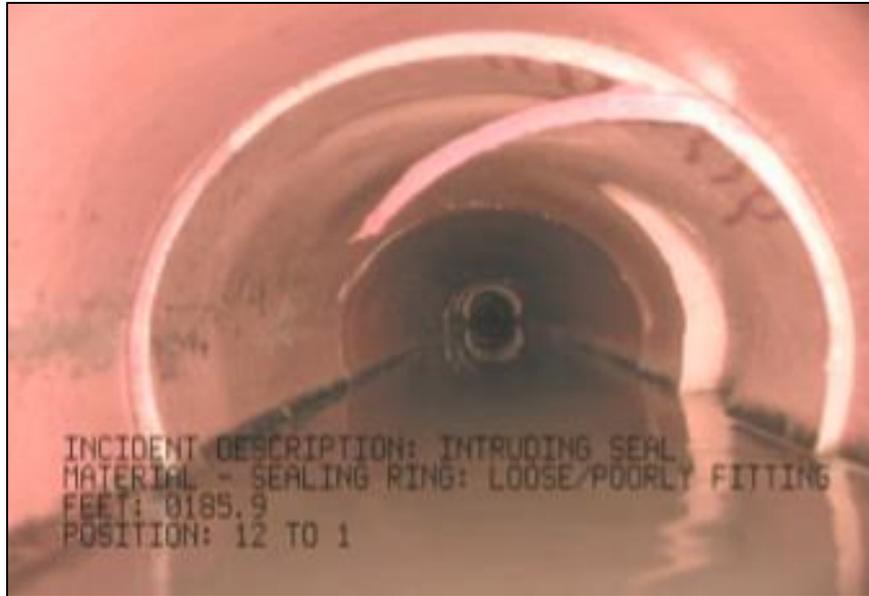
Absence/peeling of joint seal material is another sign of infiltration that might not be actively leaking during inspection. Figure 4-6 shows a joint with peeling seal material.

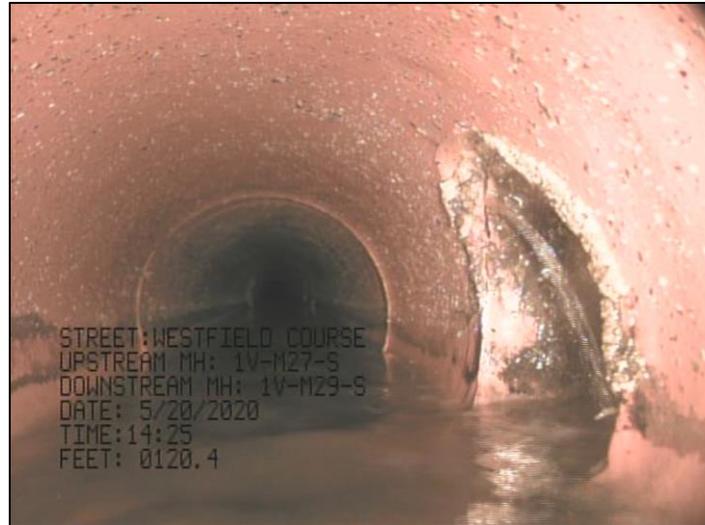
The connection point for the service at the main line is a location where infiltration is more prevalent. Figure 4-8 shows a leak at a connection point.

All service connections, in addition to the service lateral, are recommended for chemical grout. This recommendation holds for all pipes recommended for CIPP and main line chemical grout. This recommended work is located on private property (per City Code). All work on private property will require permission and hold harmless agreements.

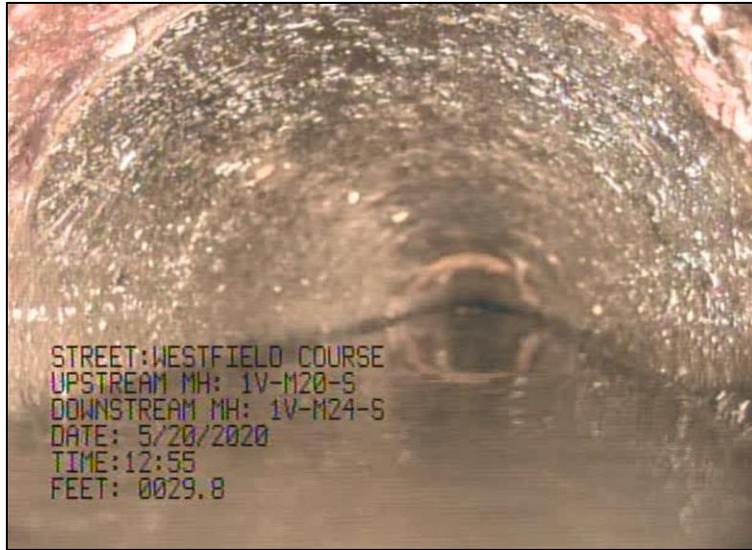
Along Westfield Course, many service connections appear to show a flat slope back to the homes. With relatively shallow sewers on Westfield (approximately 6-9 feet deep), the service connections do not appear to have significant cover from the main line. In turn, any surcharge seen in the sewer main will surcharge the service connections with low slopes. Figure 4-9 shows a service between 1V-M20 and 1V-M24, carrying half a pipe of flow at the time of inspection. Typically, service connections with proper slopes will not hold stagnant water, and only have water present when it is flowing to the main line. Figure 4-10 shows a cross section sketch of this relationship.

Deuchler is recommending all homes that have experienced wet weather SSO's and/or are shown to have flat-sloped services install an overhead system to protect their homes. Overhead sewer systems are a common way of dealing with this issue. Overhead sewer

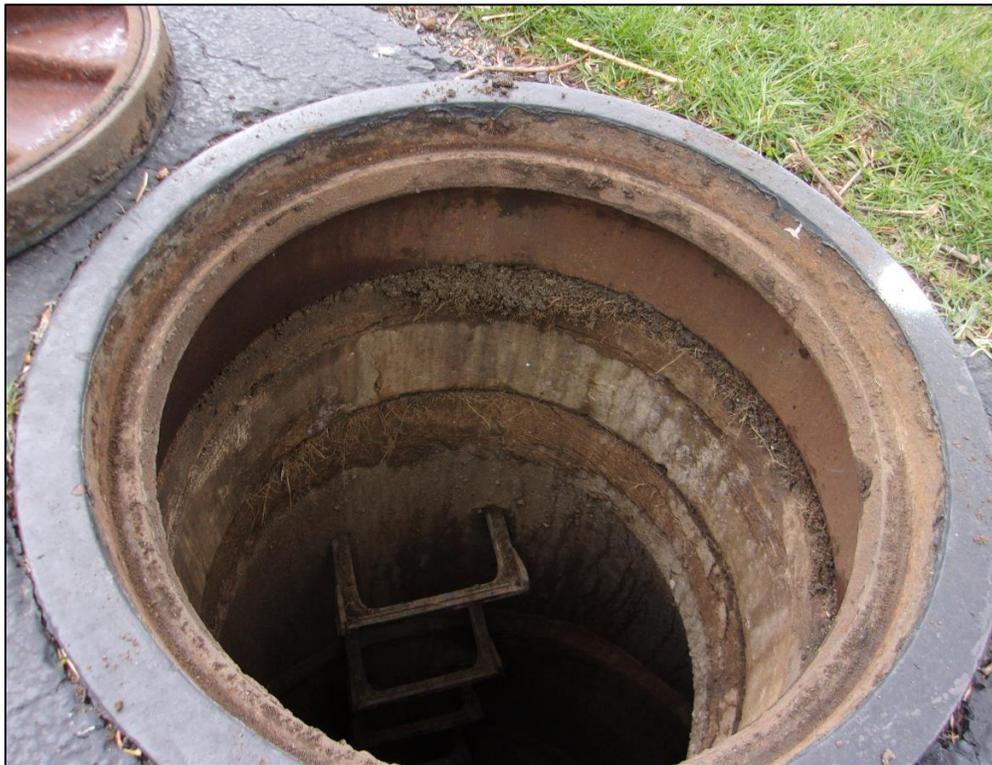
- Structures that are recommended for chimney rehabilitation had either a severe offset, fractures, roots, or evidence of significant I/I. The repair calls for new concrete rings and a proper external seal in order to keep I/I from entering the manhole. Figure 5-2 shows 1V-M37, a good example of chimney deterioration with root intrusion.

If located in a low-lying area, these defects allow a significant amount of I/I to enter the manhole. In roadways, these defects allow base material to wash into the manhole and cause cracks at the surface of the road. This is typically the most common repair item for a manhole inspection project.

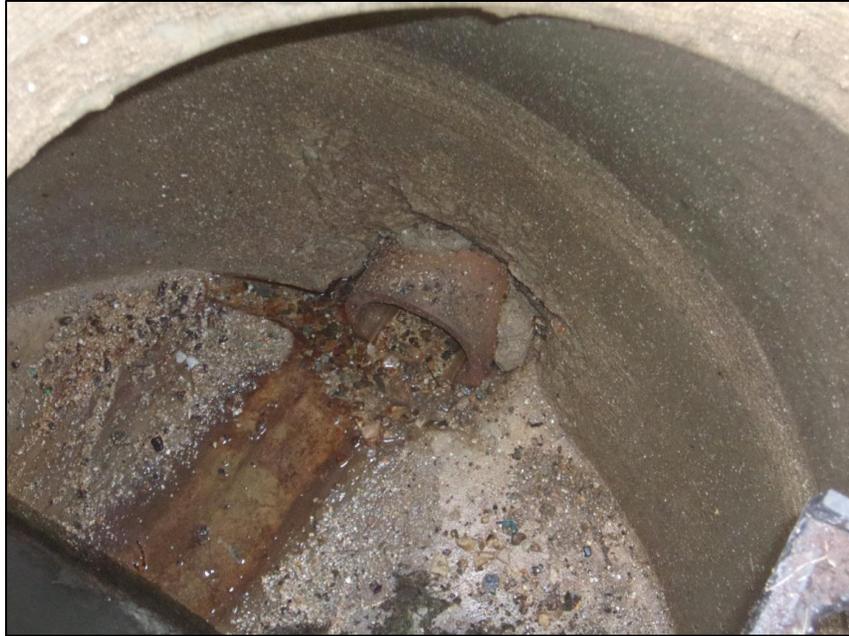
- Grouting is an industry-standard method of sealing cracks and holes that show signs of leaking inside manholes. Similar to pipelines, this method of rehabilitation focuses on removing I/I and does not structurally repair the manhole. The callouts for grouting are broken down based on the type of defect. In some cases, the infiltration is isolated to the bottom of the structure. In others, the entire manhole could benefit from grouting. Figure 5-3 shows staining and void space in 1V-M28 at the pipe entering from the north. Grout will seal the voids and prevent infiltration from entering the manhole.

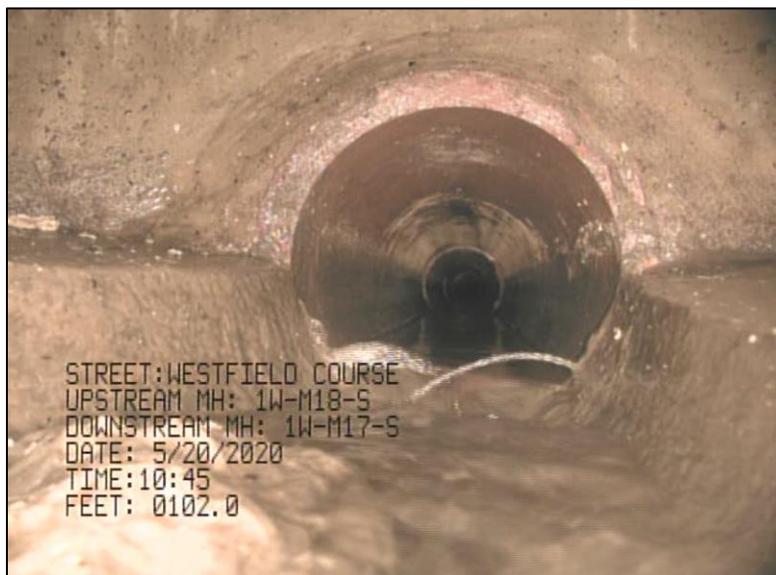
- Pipe seals, where pipes enter a manhole, is another common location of I/I entering the system. Figure 5-4 shows an example of Westfield Course. Injecting chemical grout at the bottom of a manhole can shore up the pipe seals in a manhole.

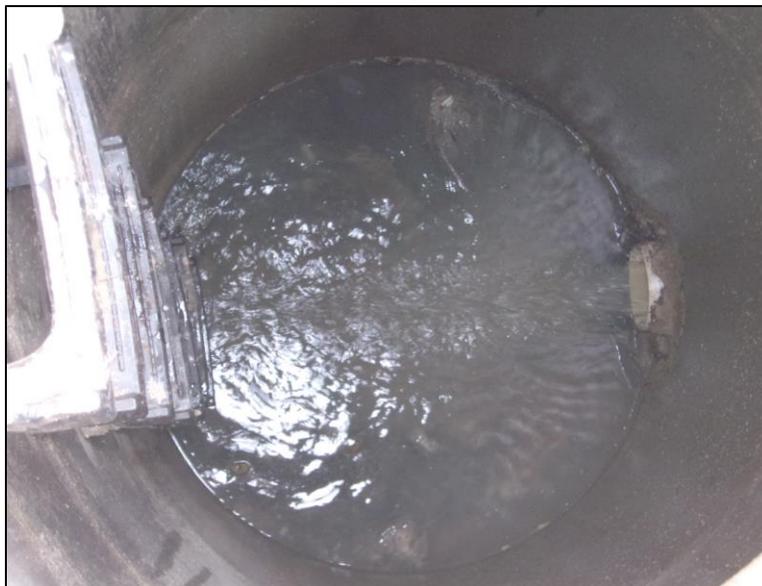
- Bench and trough defects can have a significant impact on the hydraulics of a sewer system. In manholes where the trough acts as a sump, significant head loss occurs which reduces the capacity of the system during wet weather events. In this case, a replacement bench and trough is recommended. Figure 5-5 shows the non-existent bench and trough in 2W-M12. Additionally, debris will settle out and pile up in the manhole. If enough debris settles out, the sewer has potential to plug and prevent flow from passing through.

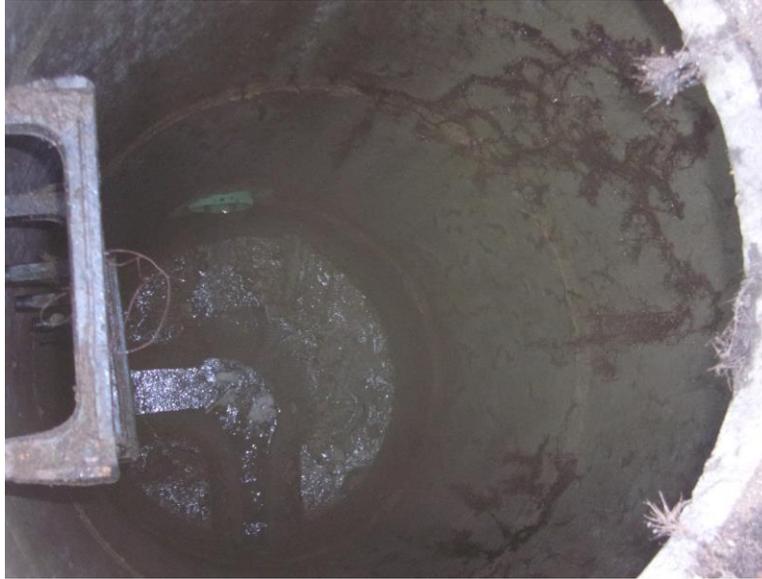
- For brick/block (occasionally precast) manholes that show signs of I/I and are also in need of a structural lift, a cementitious coating is recommended. This repair method will seal up the often-porous nature of brick/block structures and provide a layer of structural support. This repair item is also recommended for root intrusion. Figure 5-6 shows root intrusion into 1V-M28, which will require a cementitious coat.
