**RESOLUTION NO. 2022-5:
RESOLUTION AUTHORIZING EXECUTION OF
AGREEMENT to
Rebuild Spare Water Well Components**

Re: Byron Jackson Spare Well Pump Components

CITY OF GENEVA
 SPARE COMPONENTS
 INSPECTION REPORT

JOB NAME	Geneva Spare Components		WELL NO.		DATE	04/08/2022
JOB NO.	1147838	INSPECTED BY	J. Iverson, J. Kopp			
		BOWL ASSEMBLY	Byron Jackson 14 stage 13MQ/12MQL			
		MOTOR	Byron Jackson 300 HP, 14", 2300V, Type H

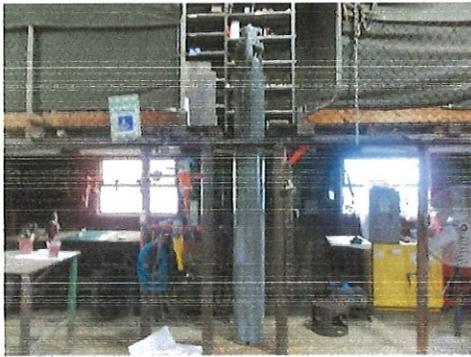
Byron Jackson 300 HP, 14", 2300V, Type H submersible motor in Layne inspection bay. S/N 14T-1003-4-1

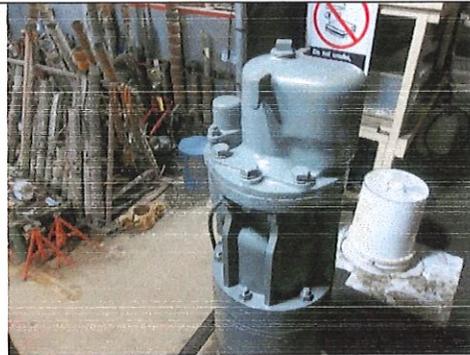
Top of motor prior to shipping cap removal.

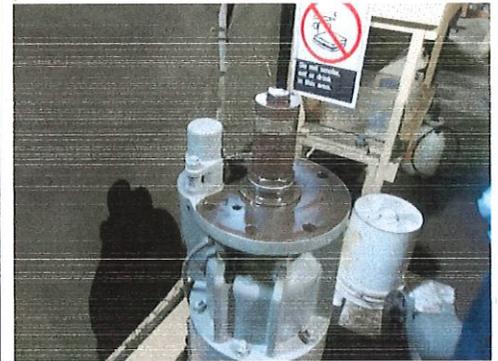
Top of motor after shipping cap removal.

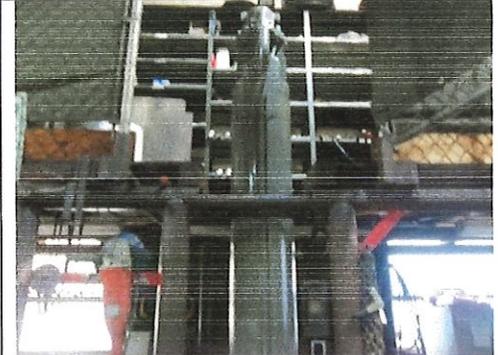
Stator body

Motor meets all specifications for return to service and appears in excellent condition. Reference attached Byron Jackson Motor Inspection – Type H report.

Return to service.

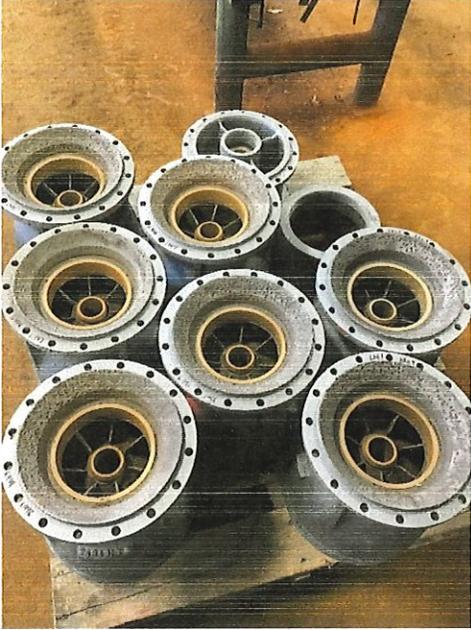
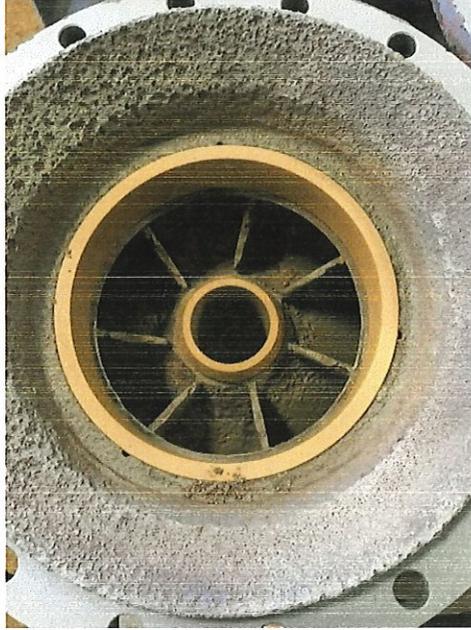
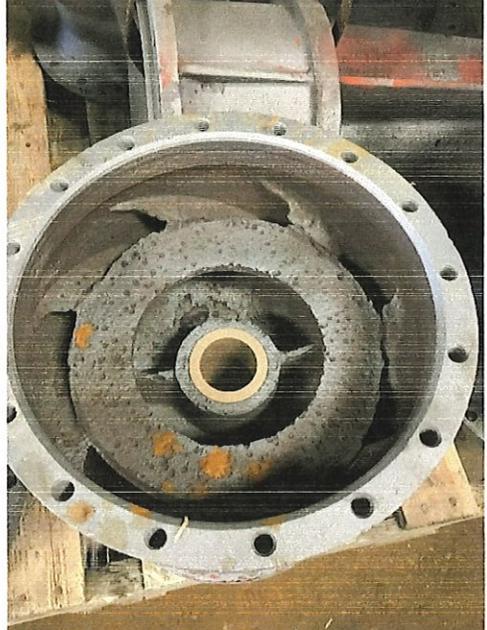
Representation of bowls after disassembly and sand blast	Upper casting (typ.)	Lower casting (typ.)

Wear ring clearances generally mic .034" to .042" with one at .056" and one at .064". Bushing clearances mic at .010" to .011". Impellers good for reuse. Outer cases are fair with moderate pitting. Interior cases have moderate vane erosion and side wall deterioration. Bowl does not have discharge pup. Fasteners are carbon steel. Stainless steel strainer and collets are OK for reuse. Impeller shaft is OK for reuse. Top case flange has wash out deterioration to threads.

Rebuild bowl with polish and straighten impeller shaft, deburr and polish collets, true impellers, new custom wear rings, apply steel epoxy to casting exterior pitting, and ceramic coat accessible casting interiors. Install 8" x 3' T&C epoxy coated discharge nipple.

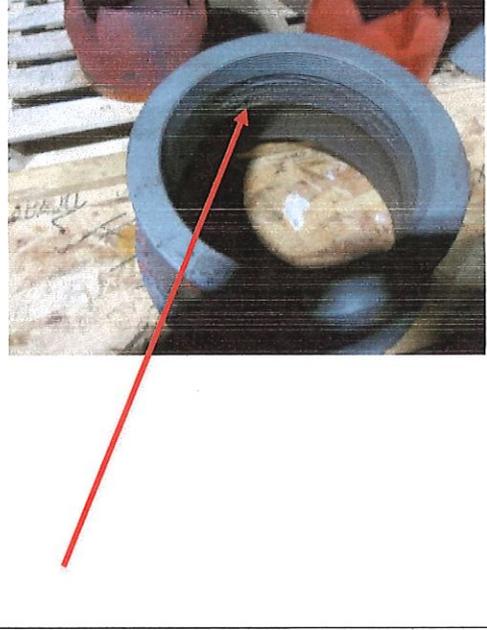
Impellers	Bushing location on impeller shaft (typ.)	Top Case flange with erosion to threads

Project		Geneva, IL		Well No.	Spare	Date	4-7-2022
Project No.		1147838		Inspected by		John Kopp	
Serial No.		Byron Jackson CIBF		Bowl Assembly		13/12MQL – 14 Stage	
Stage No.	Wear Ring	Impeller Skirt	Clearance	Bearing ID	Impeller Shaft	Clearance	
1 (suction)	6.482	6.448	.034	1.948/1.947	1.937	.011/.010	
2	6.487	6.449	.042	1.947	1.937	.010	
3	6.482	6.448	.034	1.947	1.937	.010	
4	6.484	6.449	.035	1.948	1.937	.011	
5	6.477	6.413	.064	1.946	1.937	.009	
6	6.480	6.447	.033	1.947	1.937	.010	
7	6.486	6.449	.037	1.948	1.937	.011	
8	6.484	6.449	.035	1.948	1.937	.011	
9	6.484	6.449	.035	1.947	1.937	.010	
10	6.484	6.448	.036	1.948	1.937	.011	
11	6.490	6.450	.040	1.948	1.937	.011	
12	6.488	6.449	.039	1.947	1.937	.010	
13	6.506	6.450	.056	1.947	1.937	.010	
14	6.482	6.448	.034	1.948	1.937	.011	
			Top Case	1.948	1.937	.011	
			Port Body	1.948	1.937	.011	
<p>Note: Set up for use with 14" motor and 8" discharge (no pup installed), top case flange has threads washed out and needs to be replaced. I should have a good used option available.</p>
