FACILITY CONDITION ASSESSMENT

Police Department

20 Police Plaza, Geneva IL

DATE: 10/18/2021

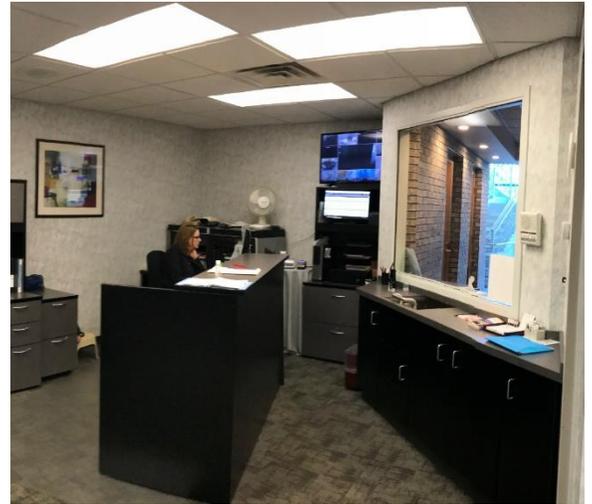
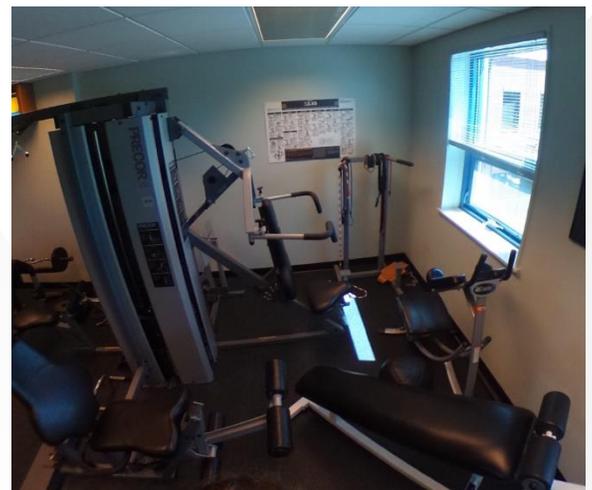
- *Walls in the administration area, and other areas, were not constructed to minimize sound transfer. Conversations can be heard between rooms readily. There is no space that allows for private and confidential topics. The department currently contracts with a company for victim services/counseling and there is no adequate location for them to work and conduct highly sensitive interviews.*

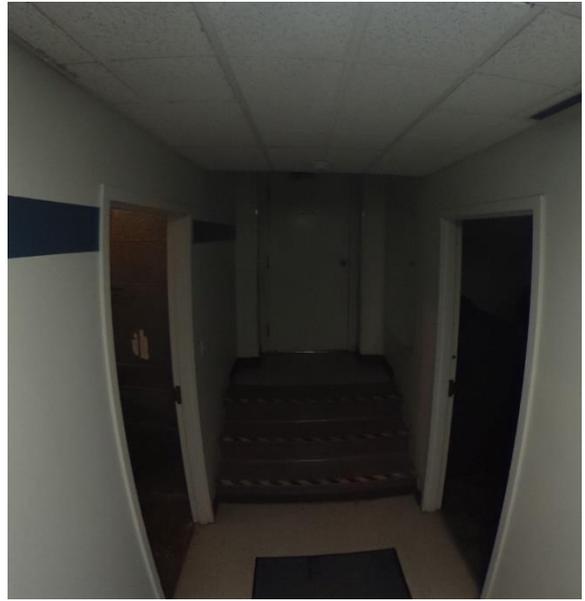
- *Not enough meeting spaces for staff or Investigations.*
- *No collaboration or dedicated meeting spaces for Investigations.*
- *No training areas of any quantity and size. This jeopardizes staffing flexibility, compliance with future regulations, and efficiencies as outside spaces need to be procured and there are limited training areas across the City.*

- *The evidence area is undersized.*
 - *No room for vehicle processing.*
 - *Not enough storage for long term evidence.*
 - *Evidence processing is properly sized, but equipment and configuration are inefficient. Additionally, the ductwork is not isolated so odors from the processing process, or evidence gathered, infiltrates into the adjacent administrative space.*

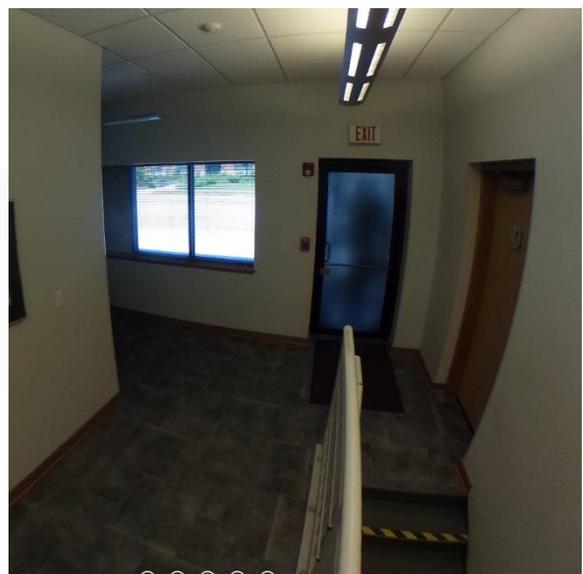
- *Current cameras are outdated and do not have sufficient storage, remote access options, or resolution to meet current needs.*
- *No panic alarms within the police facility, at records and administrative areas.*

- *Armory is not alarmed or monitored.*
- *There is a lack of monitoring or robust access control from the First Street side of the building. If one gains entry on that side, they have full access to the entire building. This includes access through the finance department.*

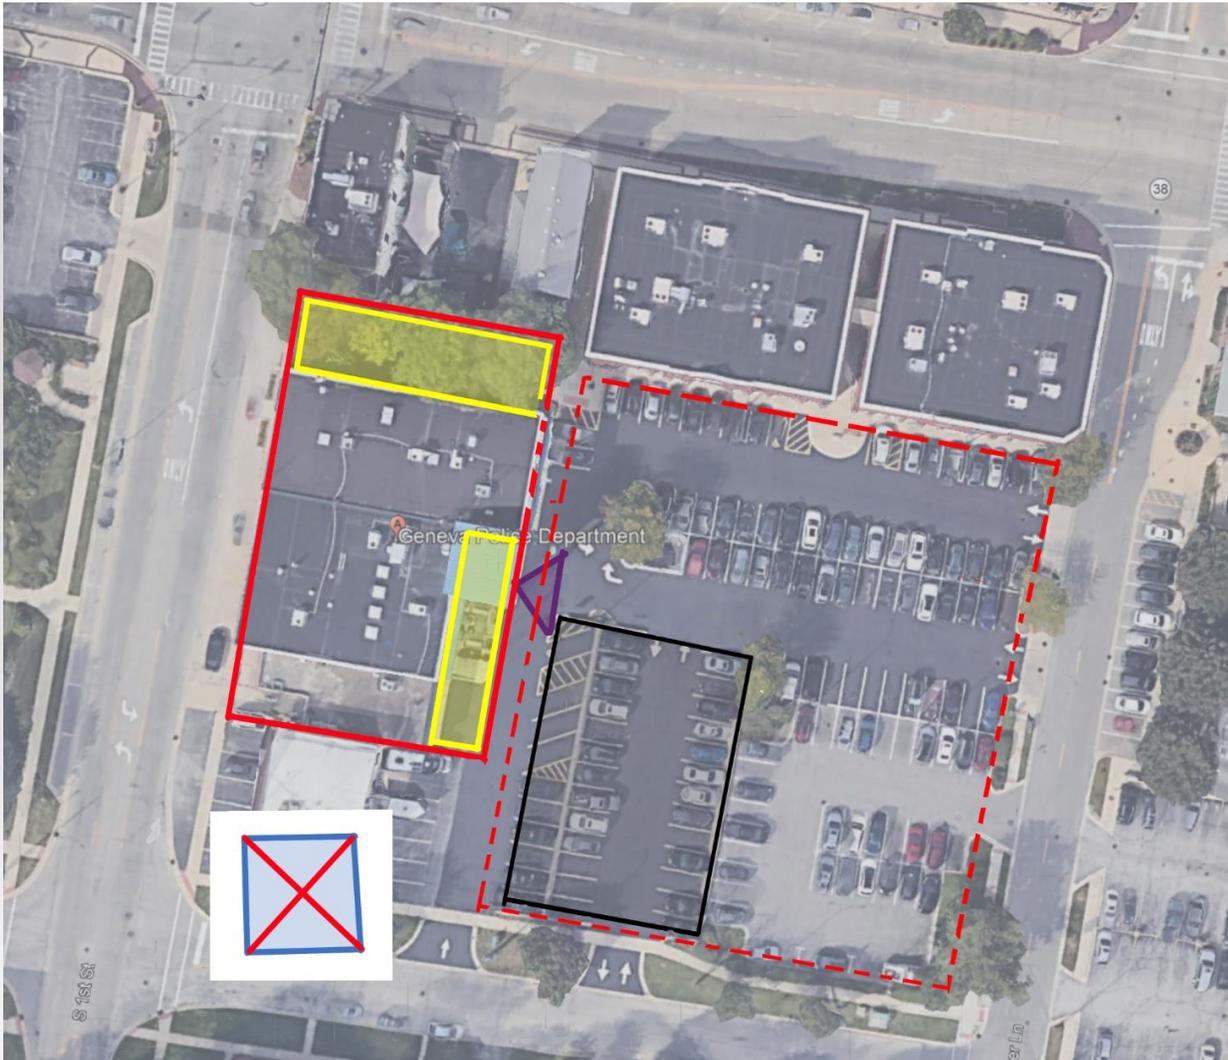
A part of this analysis is to give a general idea for the expansion of the existing facilities. While further programming and design will need to be done at a future time this diagram will provide an idea as to the extent of additions as well as other items mentioned in this report.

- *There is minimal potential for parking or site security measures without the acquisition of additional property. Gray area shown for police parking has no opportunities for a contiguous secure perimeter to the building and there is not sufficient public parking. Even with the addition of more property, the limited footprint within the surrounding facility would require expensive investments in parking infrastructure such as a parking deck with limited and controlled access to certain areas.*
- *If the highlighted yellow areas noted above could facilitate the needs of a potential building expansion, it does not address the significant mechanical and structural components that must be addressed in the very near future. Additionally based on*
