# Sanitary Sewer Evaluation: Geneva East Basin

City of Geneva

Prepared For  
The City of Geneva

Prepared By  
Deuchler Engineering Corp.  
230 Woodlawn Avenue  
Aurora, IL 60506  
[www.deuchler.com](http://www.deuchler.com)

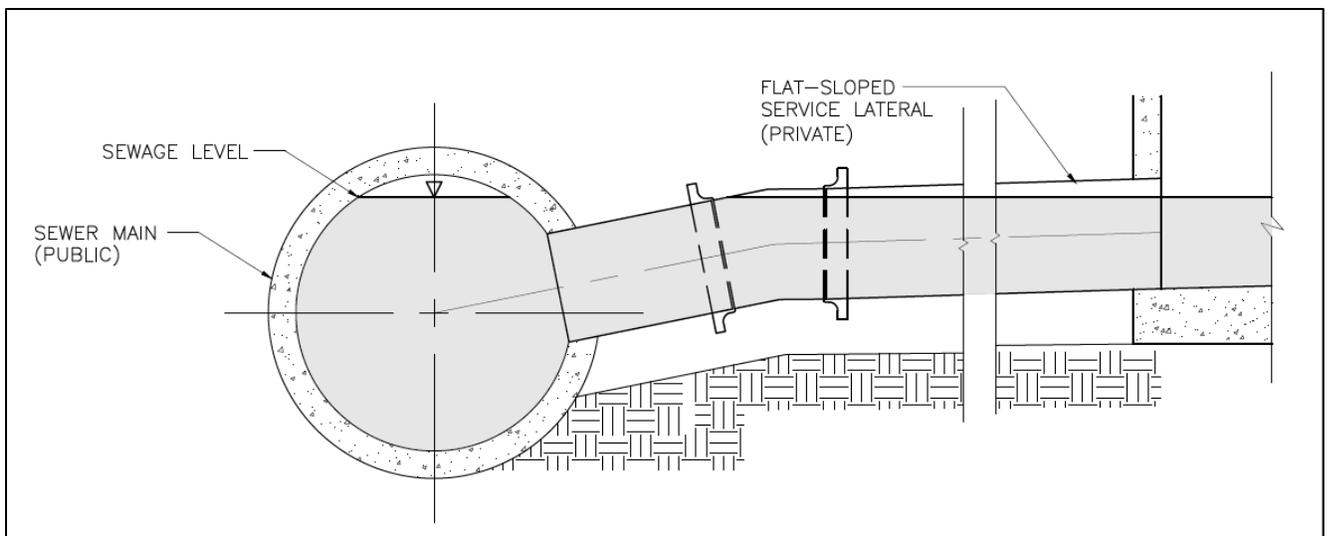
Along Westfield Course, many service connections appear to show a flat slope back to the homes. With relatively shallow sewers on Westfield (approximately 6-9 feet deep), the service connections do not appear to have significant cover from the main line. In turn, any surcharge seen in the sewer main will surcharge the service connections with low slopes. Figure 4-9 shows a service between 1V-M20 and 1V-M24, carrying half a pipe of flow at the time of inspection. Typically, service connections with proper slopes will not hold stagnant water, and only have water present when it is flowing to the main line. Figure 4-10 shows a cross section sketch of this relationship.

Deuchler is recommending all homes that have experienced wet weather SSO's and/or are shown to have flat-sloped services install an overhead system to protect their homes. Overhead sewer systems are a common way of dealing with this issue. Overhead sewer

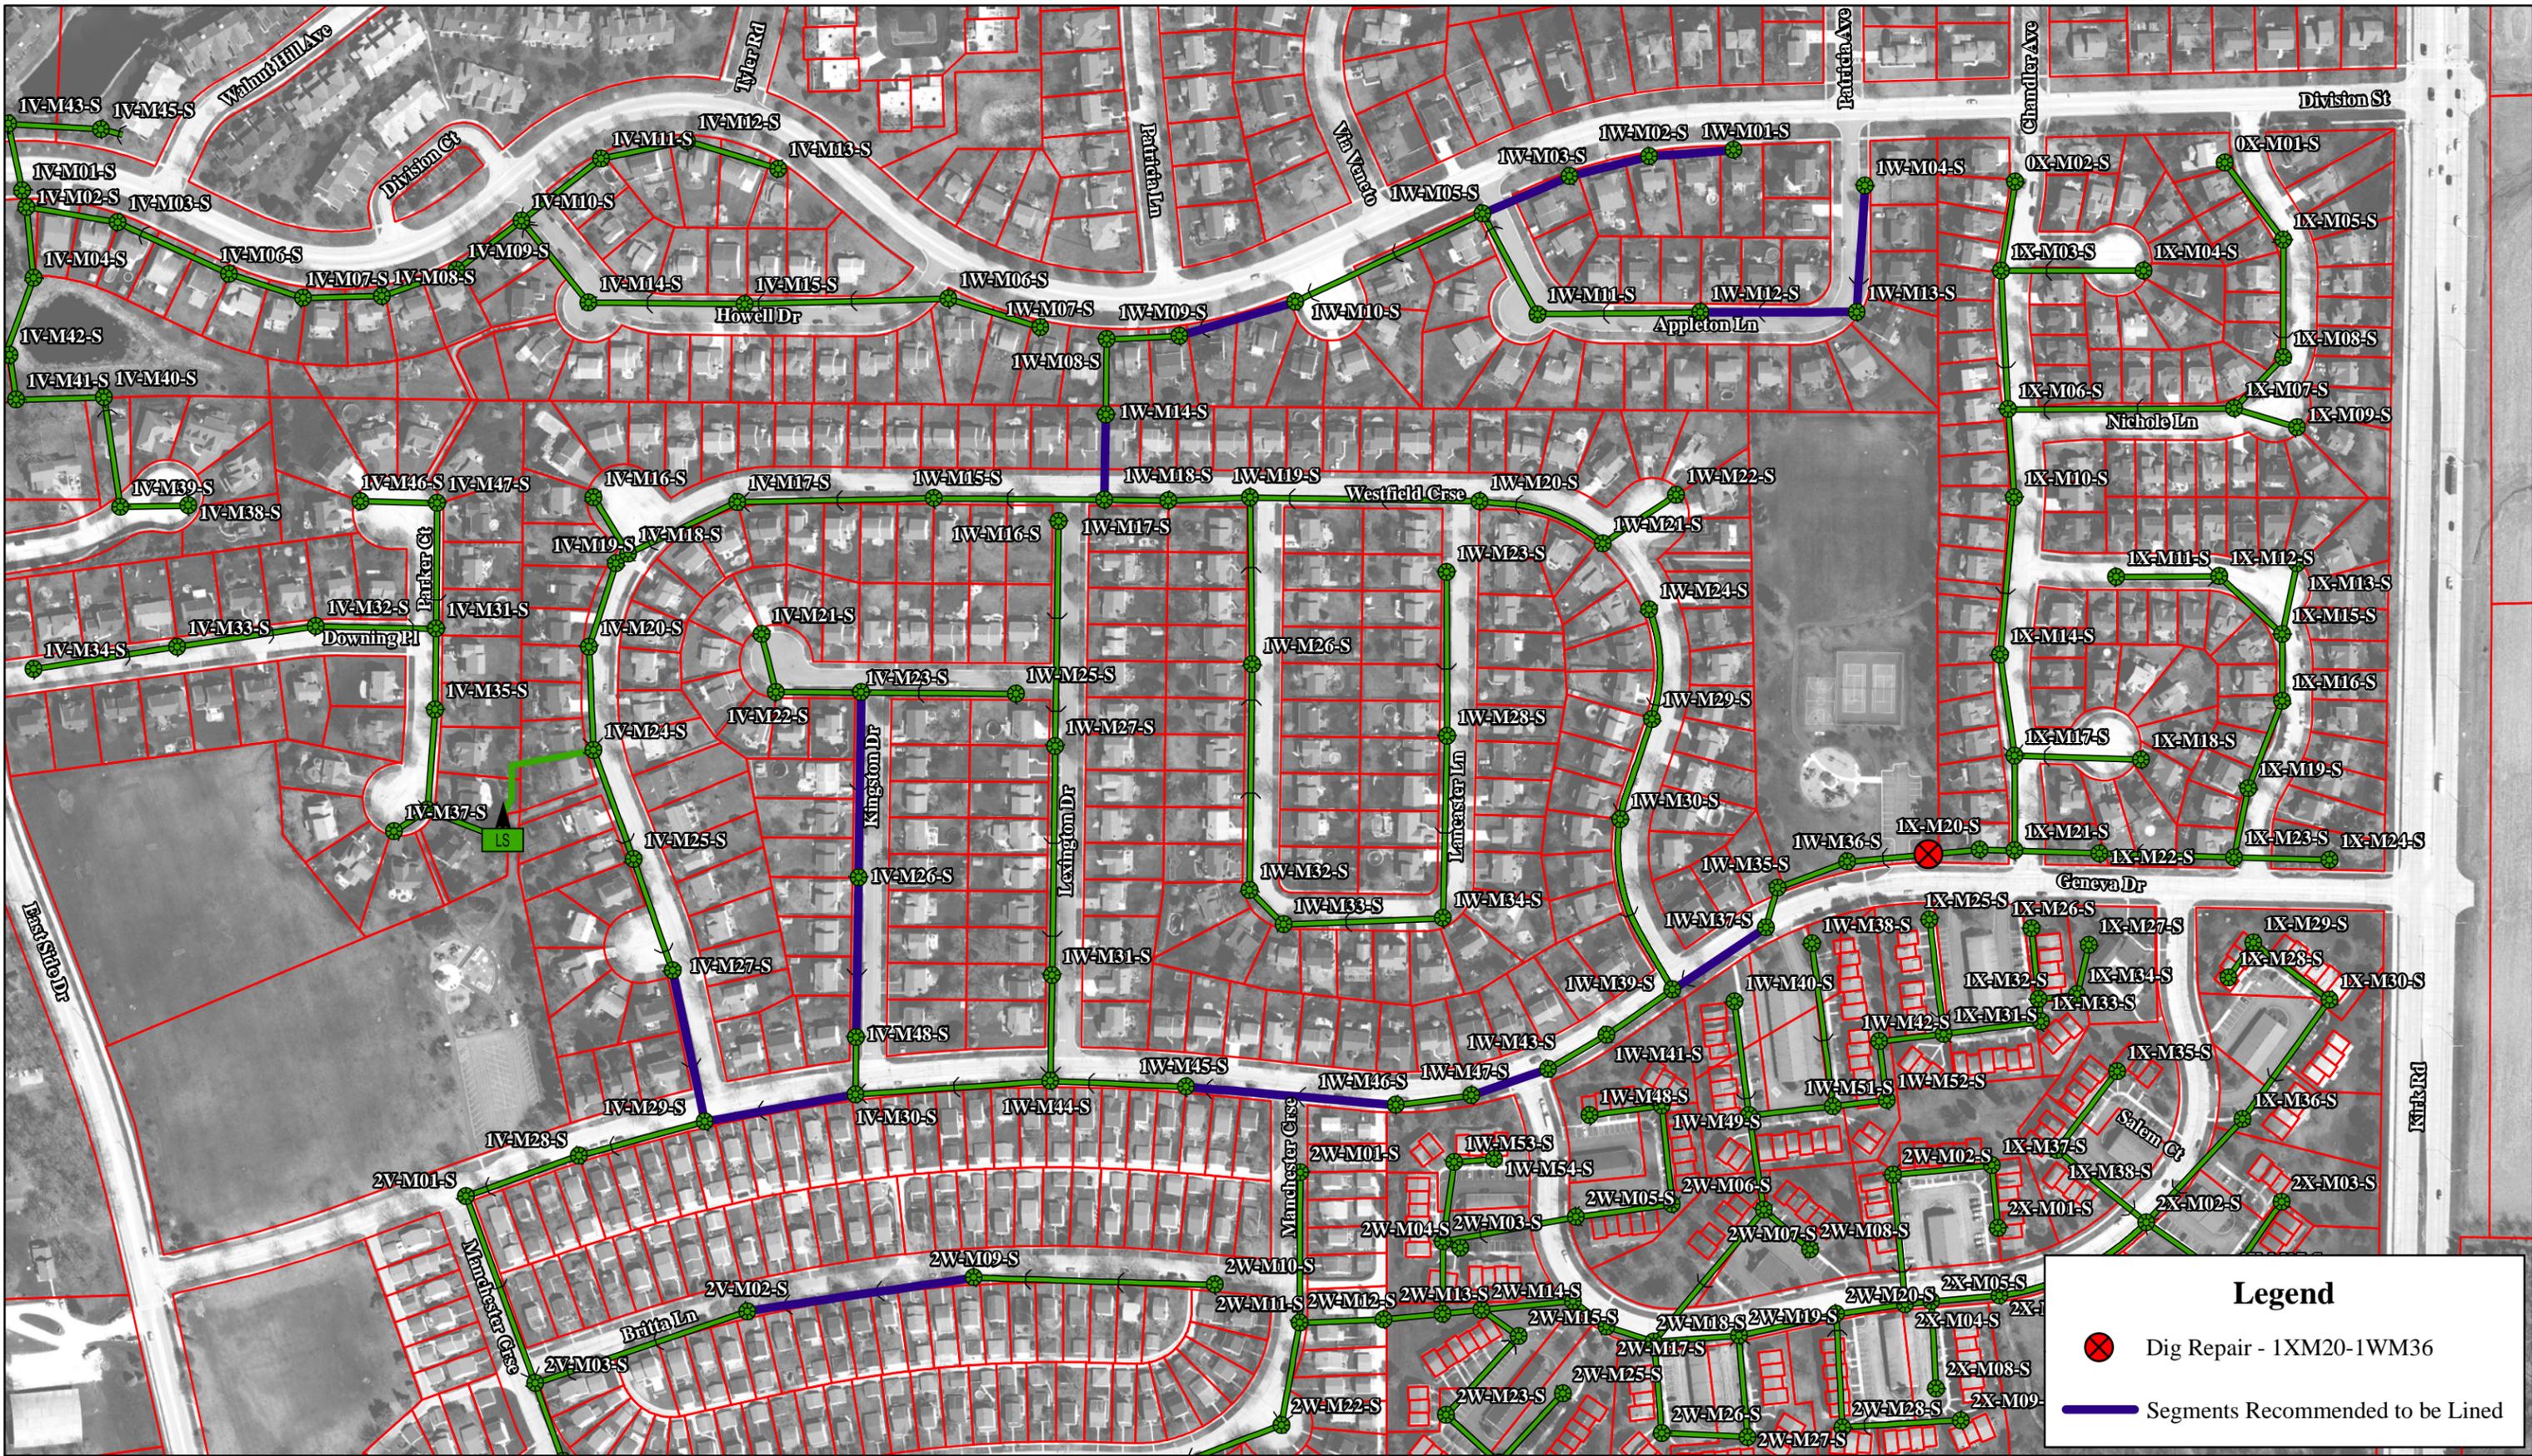
**Exhibit 4: Segments Recommended to be Lined**

In the Geneva East basin, the highest assigned rating was a 3. This was assigned 15 times. A 3 rating falls into the category of medium lining priority. In this case, each of the sewers was Vitrified Clay Pipe (VCP) and showed signs of deterioration. Some segments were labeled as medium priority that had severe root intrusion that standard grout would not be able to remediate.

Roots will often enter pipelines at the joints. Roots seek the moisture and nutrients present in sanitary sewers. When roots are found in sewers, they will often continue to grow and become a large obstruction restricting flow. Additionally, the space in the joints that allows roots to penetrate is also a source of I/I. Segments with a significant amount of roots are recommended to be lined with CIPP. Figure 4-2 shows root intrusion at a VCP joint.

- ⊗ Dig Repair - 1XM20-1WM36
- Segments Recommended to be Lined

The distressed VCP and Ductile Iron segments will be best served with mainline joint chemical grout to help eliminate inflow and infiltration. The segments with significant root intrusion are recommended for CIPP lining to ensure the roots are eliminated. Grouting and lining recommendations can be found on Exhibit 4 and Exhibit 5.

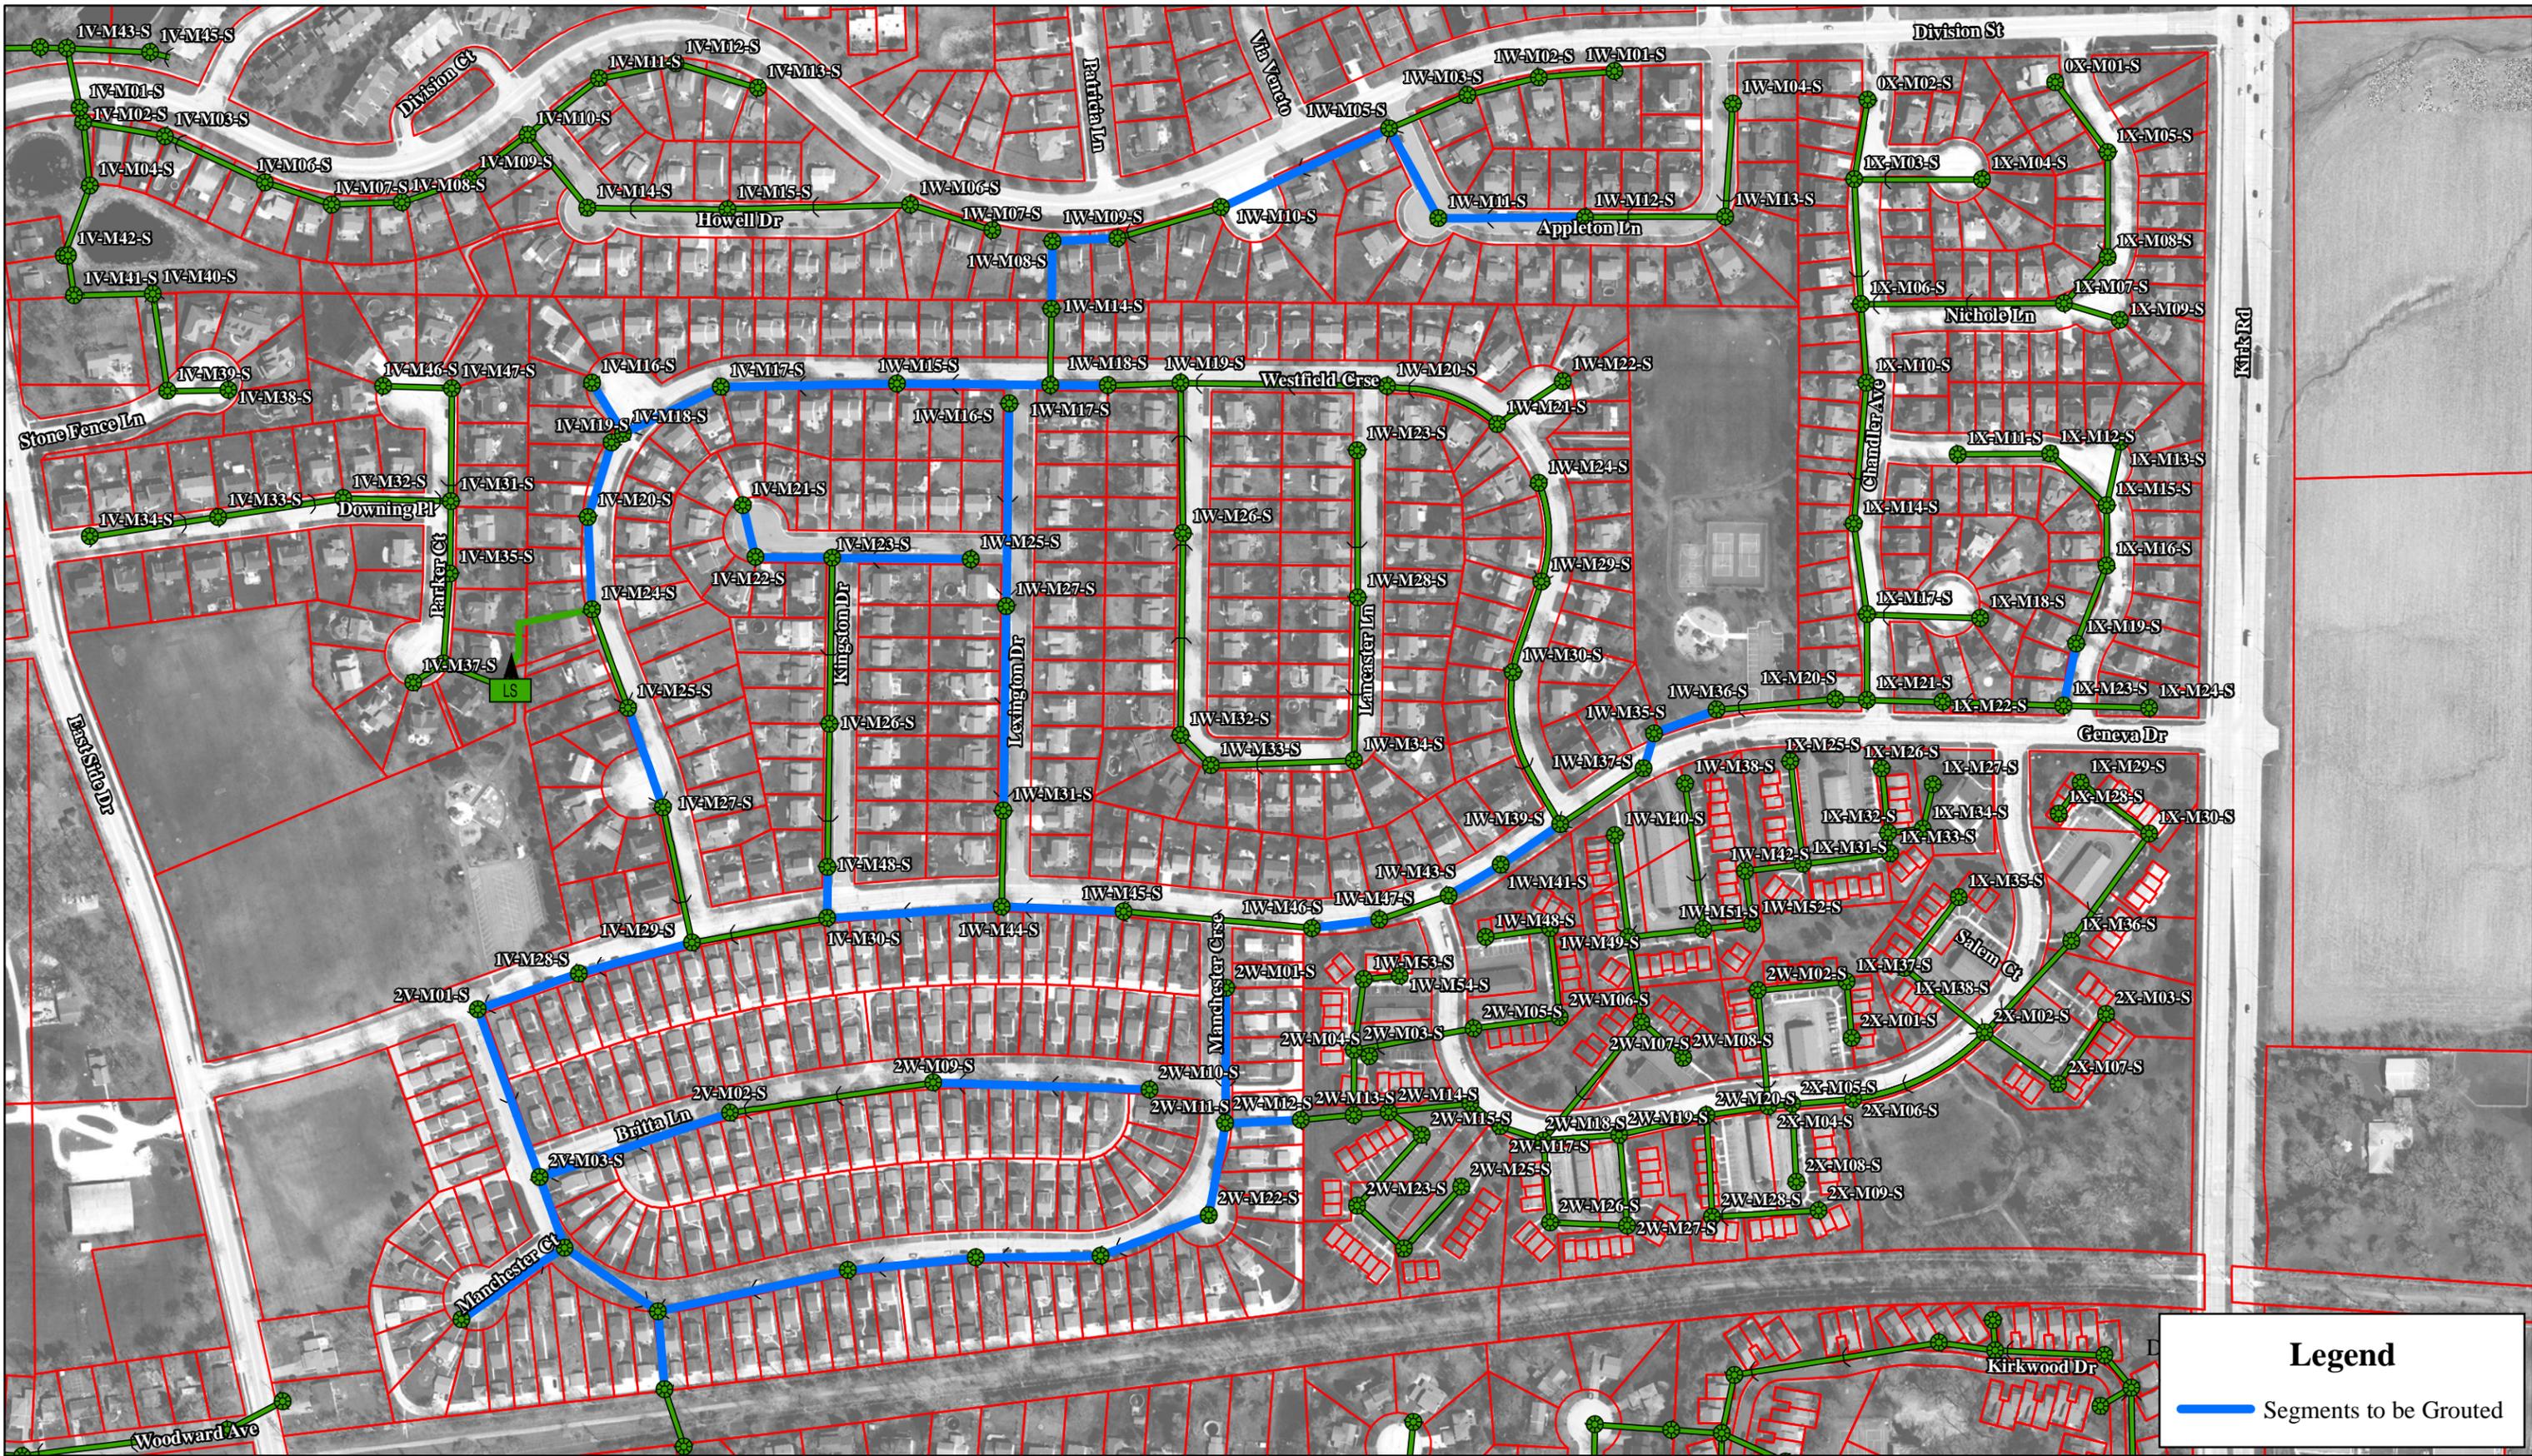
**Exhibit 6: Segments Recommended to be Grouted**

Many pipes are in good structural condition, but show active infiltration or signs of past infiltration. Segment 1W-M30 to 1W-M39 was televised on 5-20-2020, a few days after the heavy rains. This segment showed active I/I at nearly every joint. Figure 4-3 shows a few of the leaking joints.

All service connections tied with these lines are recommended for grout as well. With the nature of infiltration on the mainline as well as the high quantity in the basin, grouting is recommended for 30 feet from the main line up the service pipe. This recommended work is located on private property (per City Code). All work on private property will require permission and hold harmless agreements.
